Master's Thesis

The structural intervention of
St. Torcato Church:
documentation and analysis
of the strengthening works

University of Minho

Year: 2014

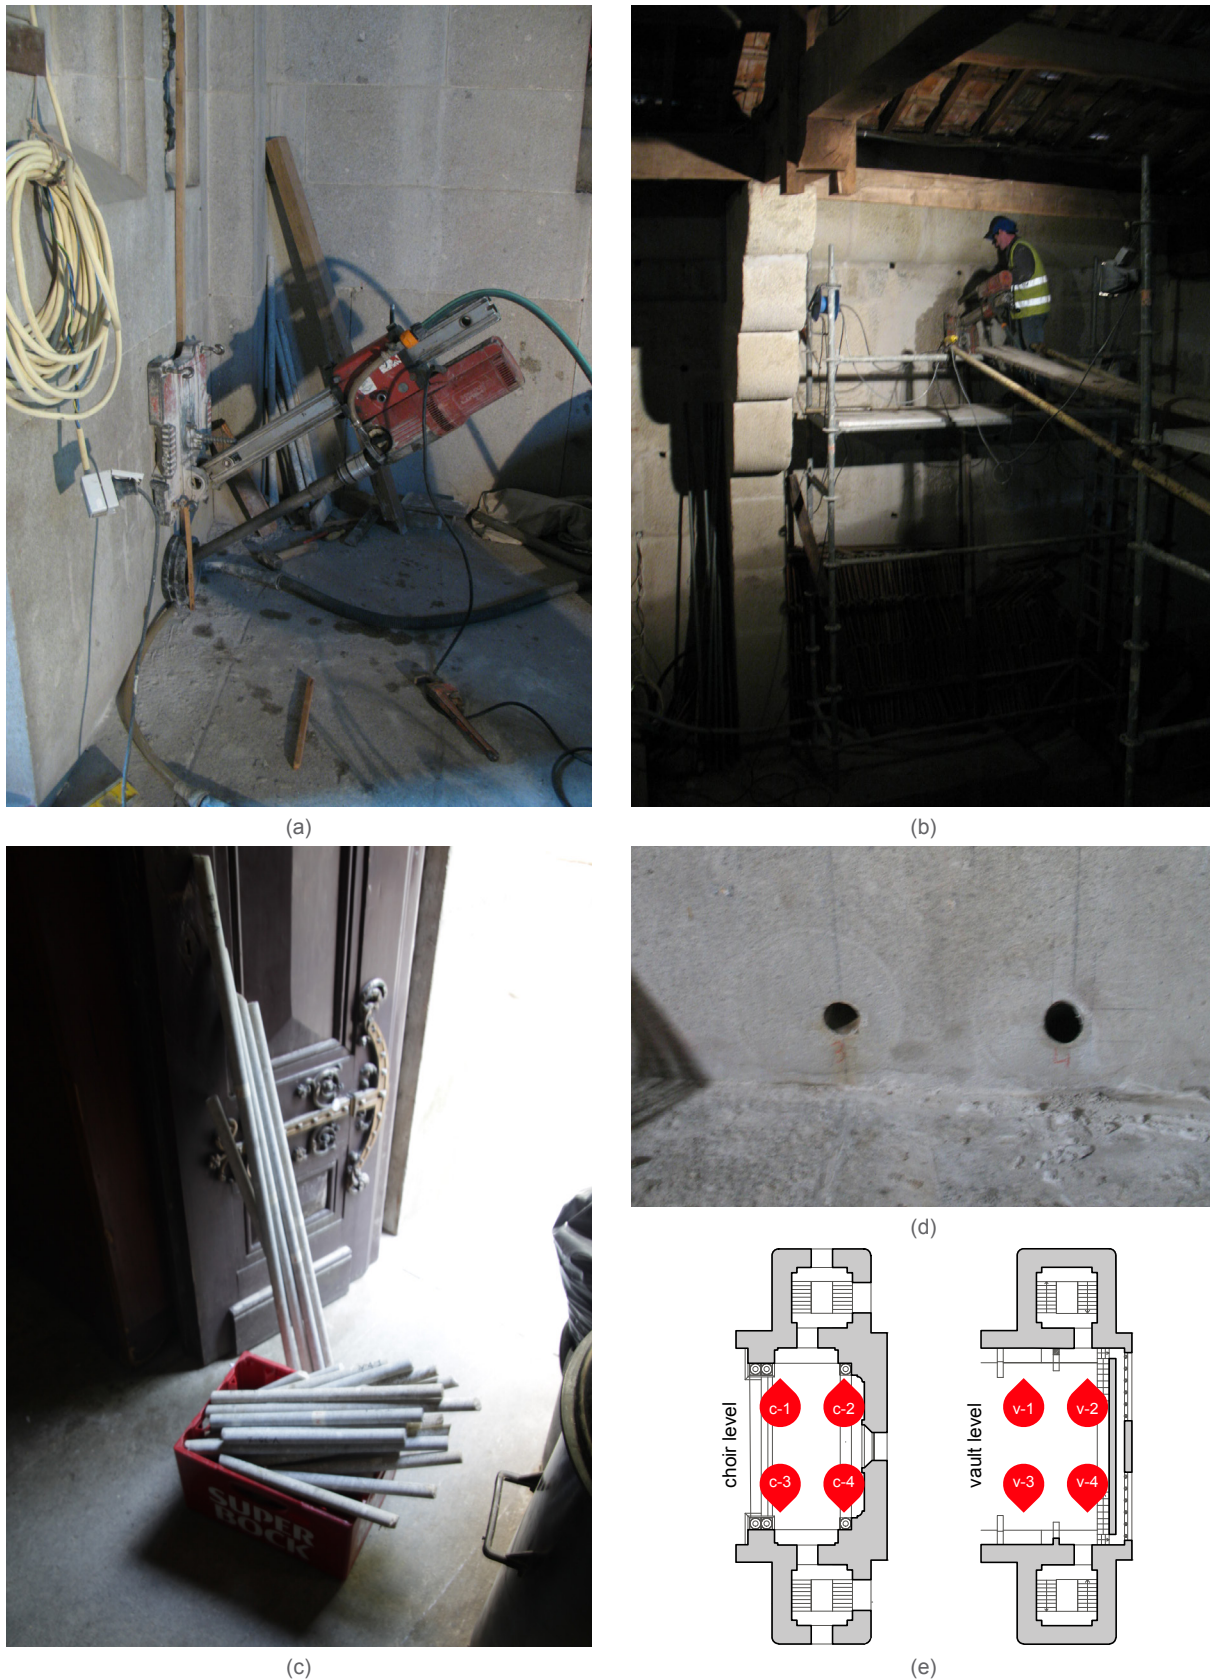
Figure 6.6: The anchoring system installation on S. Torcato: (a) coring procedure at choir level (b) coring procedure at attic level (c) the collected and cataloged specimens (d) the holes performed in the structure (e) scheme of the specimen cataloging

On 19th of May the same operation was carried out at the attic level, on the walls on top of the extrados. That time was necessary to built a specific scaffolding to reach the necessary height imposed by the design. Even this time a couple of days were necessary to finish the work (Figure 6.6).

The cores of the towers, wastes of the drilling operation, are valuable items that could be used to improve the knowledge of the mechanical properties of the church. For this reason, four specimen per drill have been collected and cataloged, using the logical scheme that is visible in Figure 6.6. Those samples could be analyzed in the future, for instance by means of uniaxial compressive tests performed in laboratory. The characteristic of the material could be, in this way, effectively compared with the ND tests previously performed (Chapter 3), in order to update the granite parameters and calibrate further analysis.

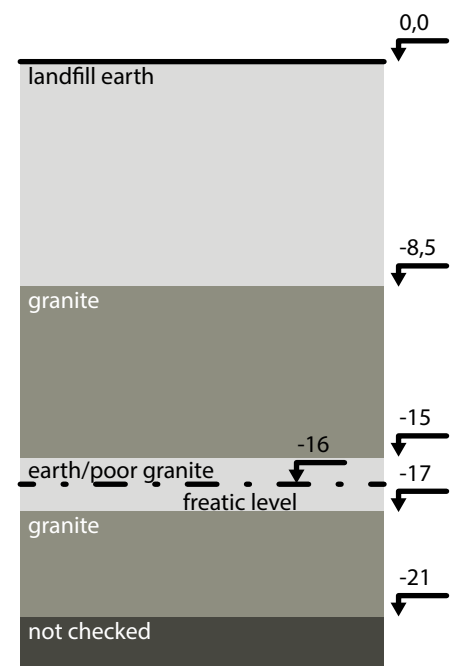
Figure 6.7: section inferred by the different soil resistance discovered during the perforations

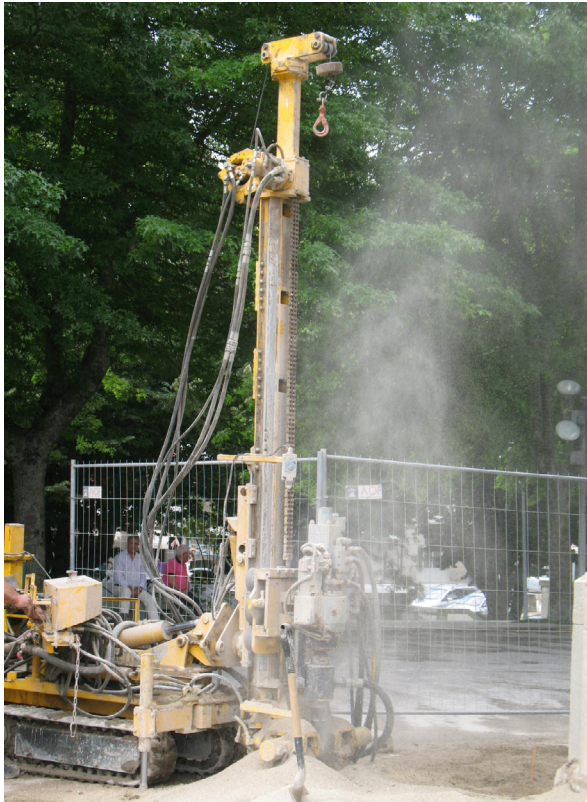
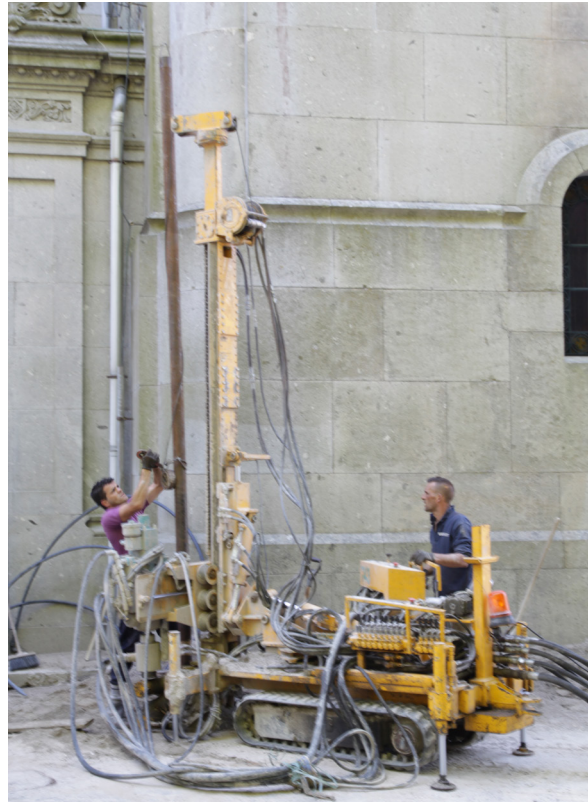
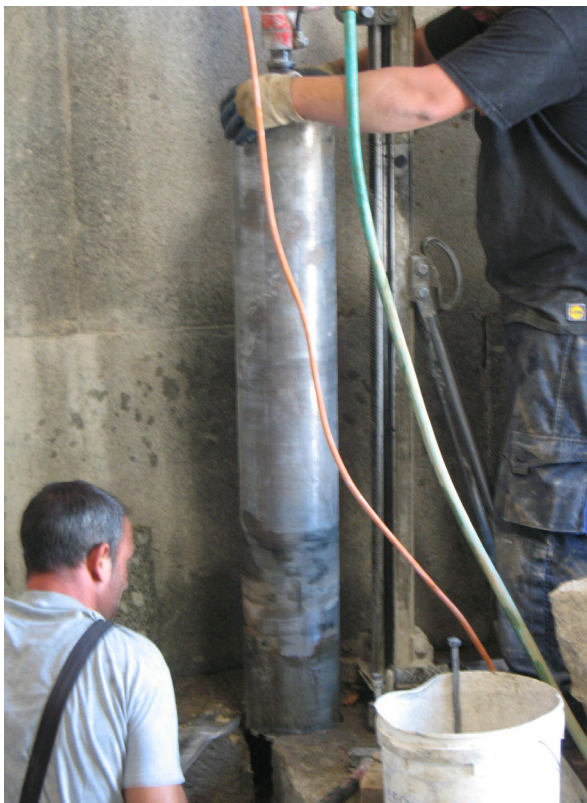
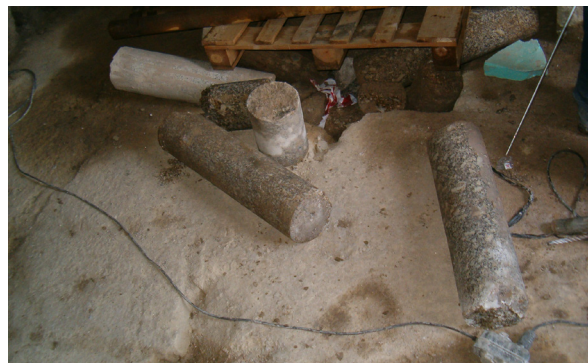
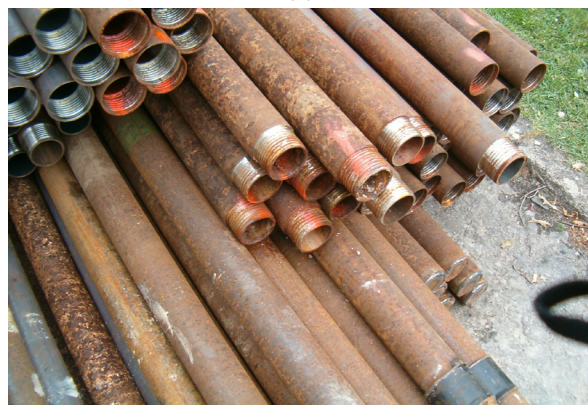
All the holes of the same side had been completed before move to the other tower. The perforation until 21 meters was achieved by means of a special auger mounted on a drilling-machine controlled by an operator. Once the holes had been completed, micro-piles would be inserted on the holes and filled with cement (Figure 6.8).

The micro-piles used for the design had to be of 8,5 cm of diameter and 8,5 mm of thickness. However, the pipes used for the operation that were found in the yard were recycled from different stocks of the oil industry. Thus, it was possible to identify three groups of piles, depending on their condition: there were piles in good status, piles with average level of rust and piles completely rusted. Moreover, the thicknesses of the piles were variable.

Figure 6.8: The strengthening of the foundation: (a) perforation of the soil until 21m (b) installation of the micro-piles (c) coring of the interior of the towers (d) the block resulting of the coring procedure (e) marking of useless micro-piles

On 25th of June 2014 all the holes of the left tower were completed and the intervention on the right tower started. Pipes in a too bad conditions were marked in order to replace them. A new cross section of the soil could be drawn thanks to perforation (Figure 6.8).

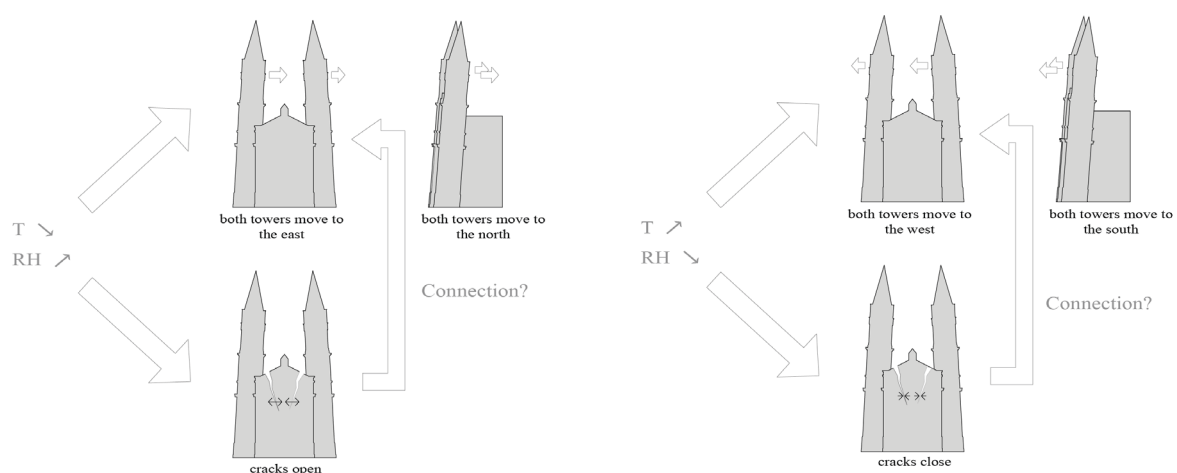
The global behavior defined by the monitoring data is the following: the cracks are still active and the towers move each time in the same direction. Their trend is strictly correlated with environmental factors. The cracks grow and the towers move relatively towards each other during temperature drops and the

Figure 6.9: Global behavior of the structure in relation with environmental effects (Gutscoven, 2014)

relative humidity incrementation: jumps on the cracks appear for rushed decrement of temperature and fast increase of the relative humidity. The opposite behavior is verified in case of increment of temperature and drop of relative humidity (Fig 6.9).

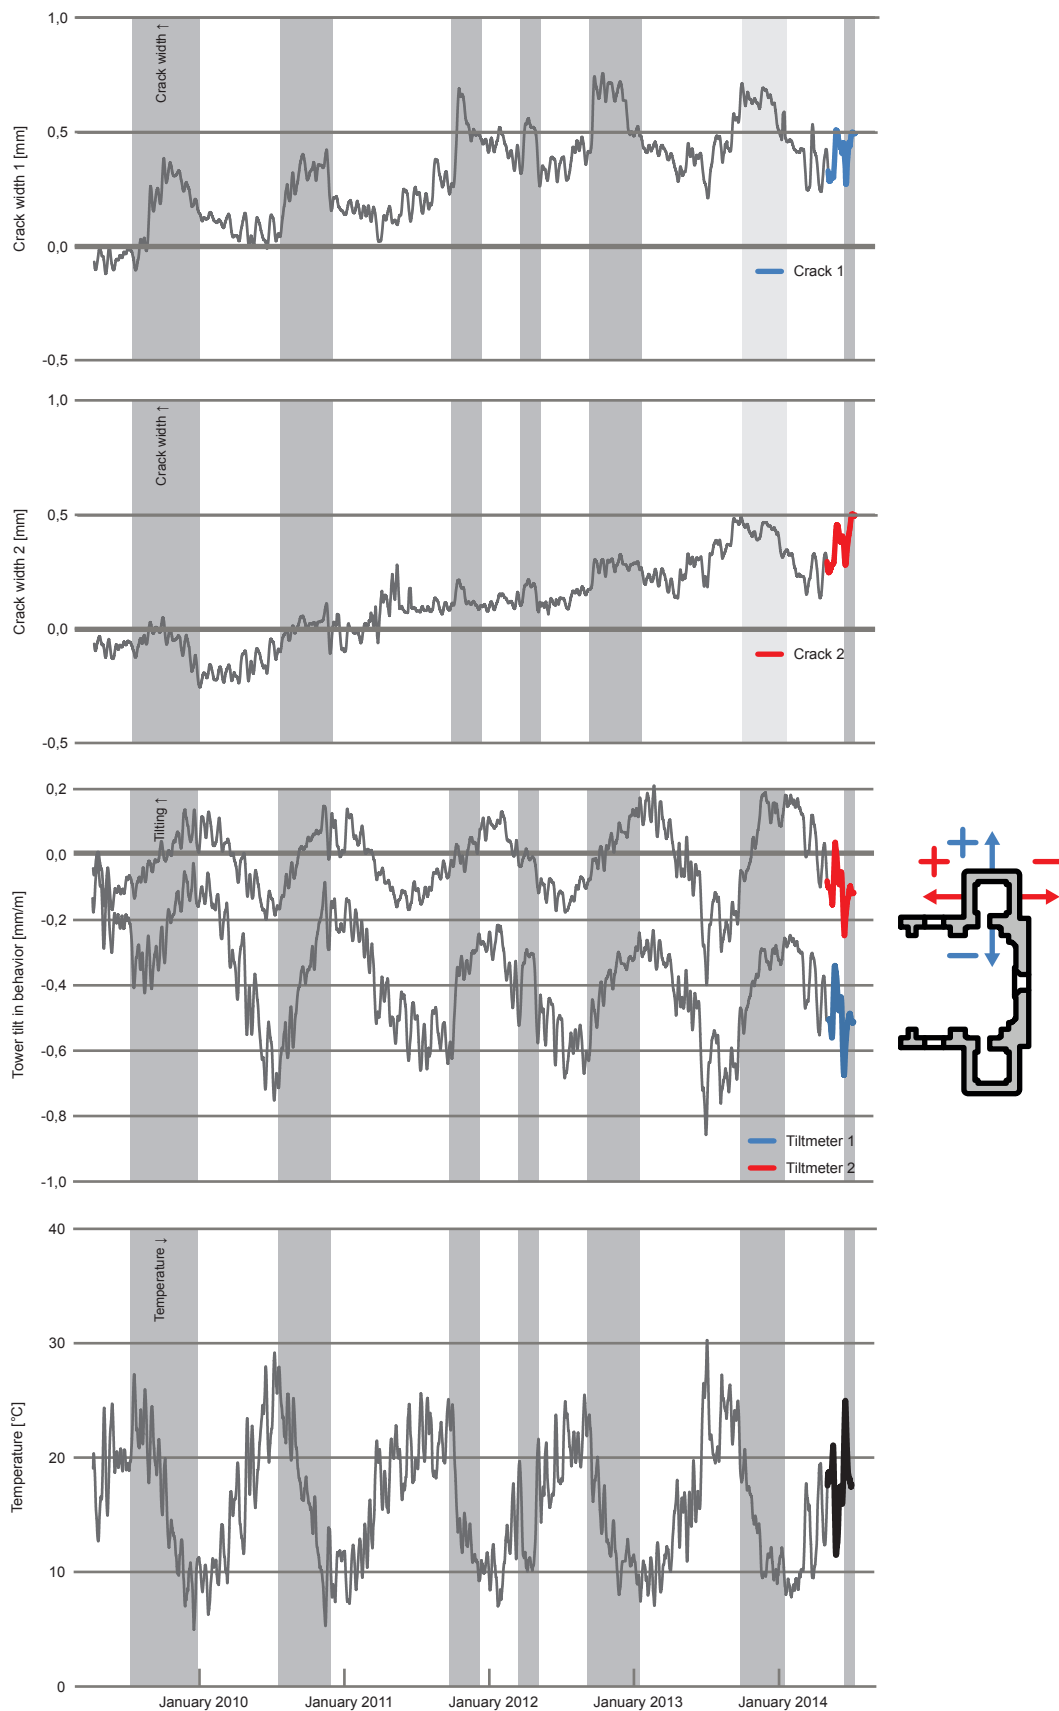
The static monitoring data was checked during the construction process. The analysis of the data do not show any relevant arouse of interference on the structure induced by the intervention. Both crack meters and tilt meters seem to follow the regular trend conditioned by the environmental conditions. It is true that the graph is much more ruced and noisy respect to the previous periods. This condition, however, can be induced by the irregular variation of the weather in the last period. The data are plotted in Figure 6.7 (for simplicity are shown just two tilt meters and the crack meters).

Figure 6.9: Analysis of the tilting and cracking monitoring data during the executions. The colored part shows the effective period of work. The gray pattern shows the behavior of the towers with respect to the environmental conditions

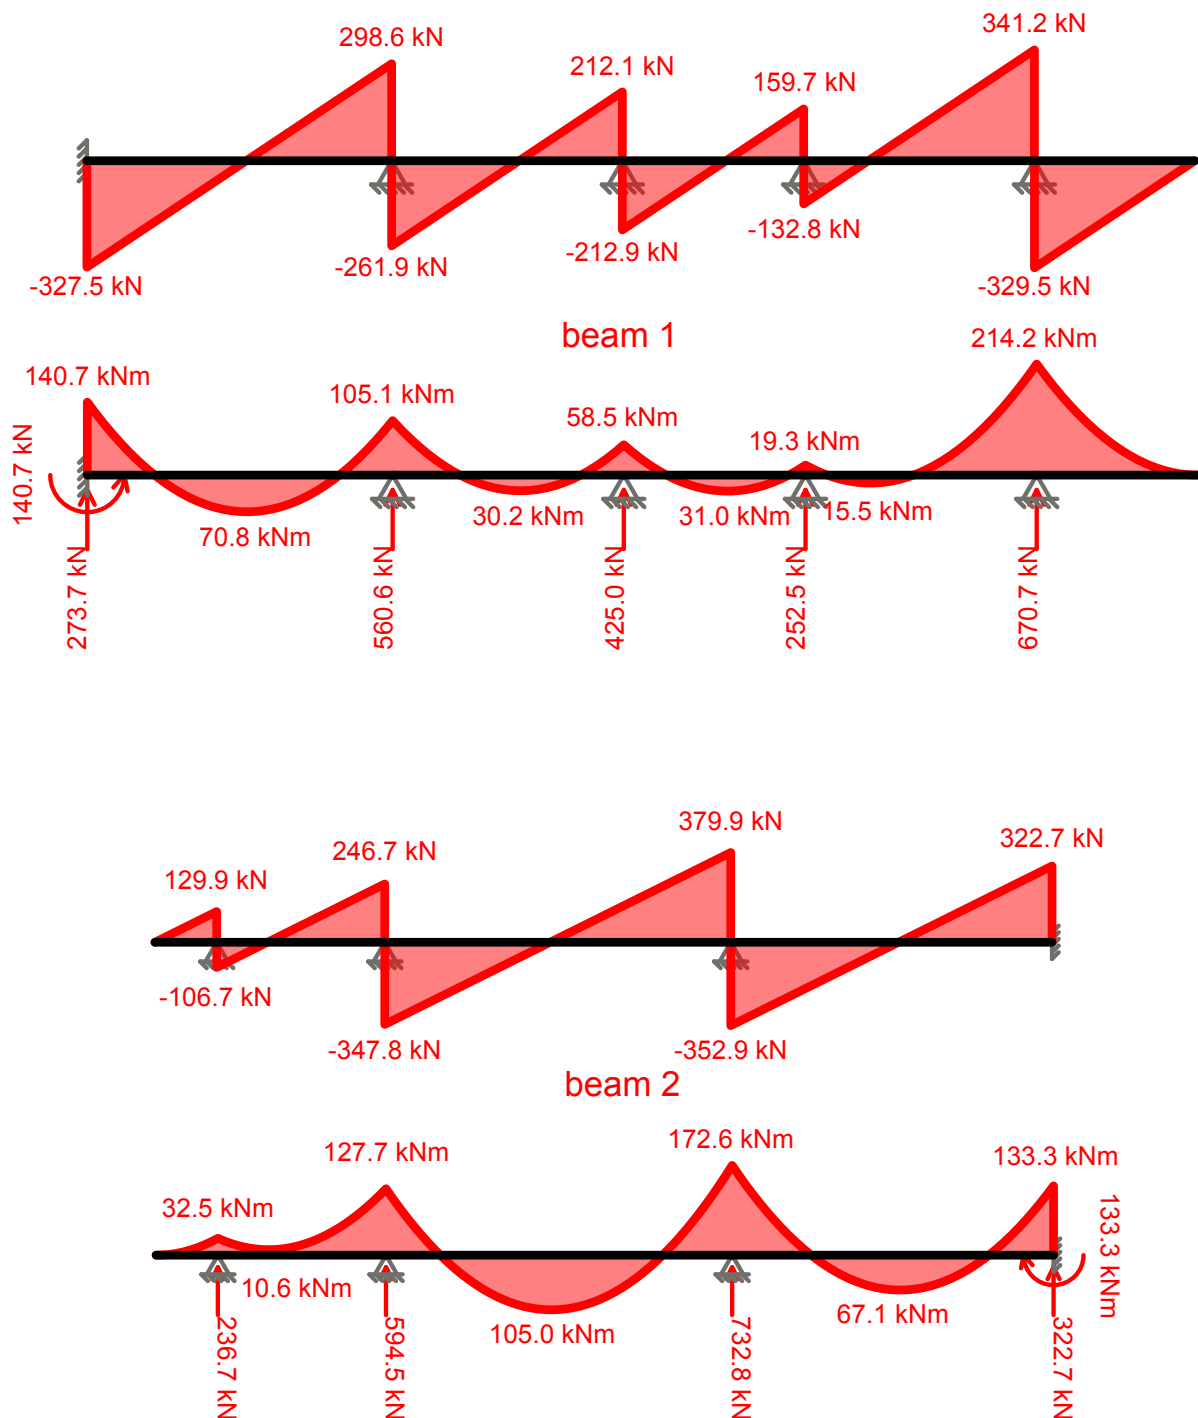
Figure B.1: Shear and bending moment diagrams on the beam 1 (on top) and beam 2 (on the bottom) for the project of Professor Ramos (personal work)

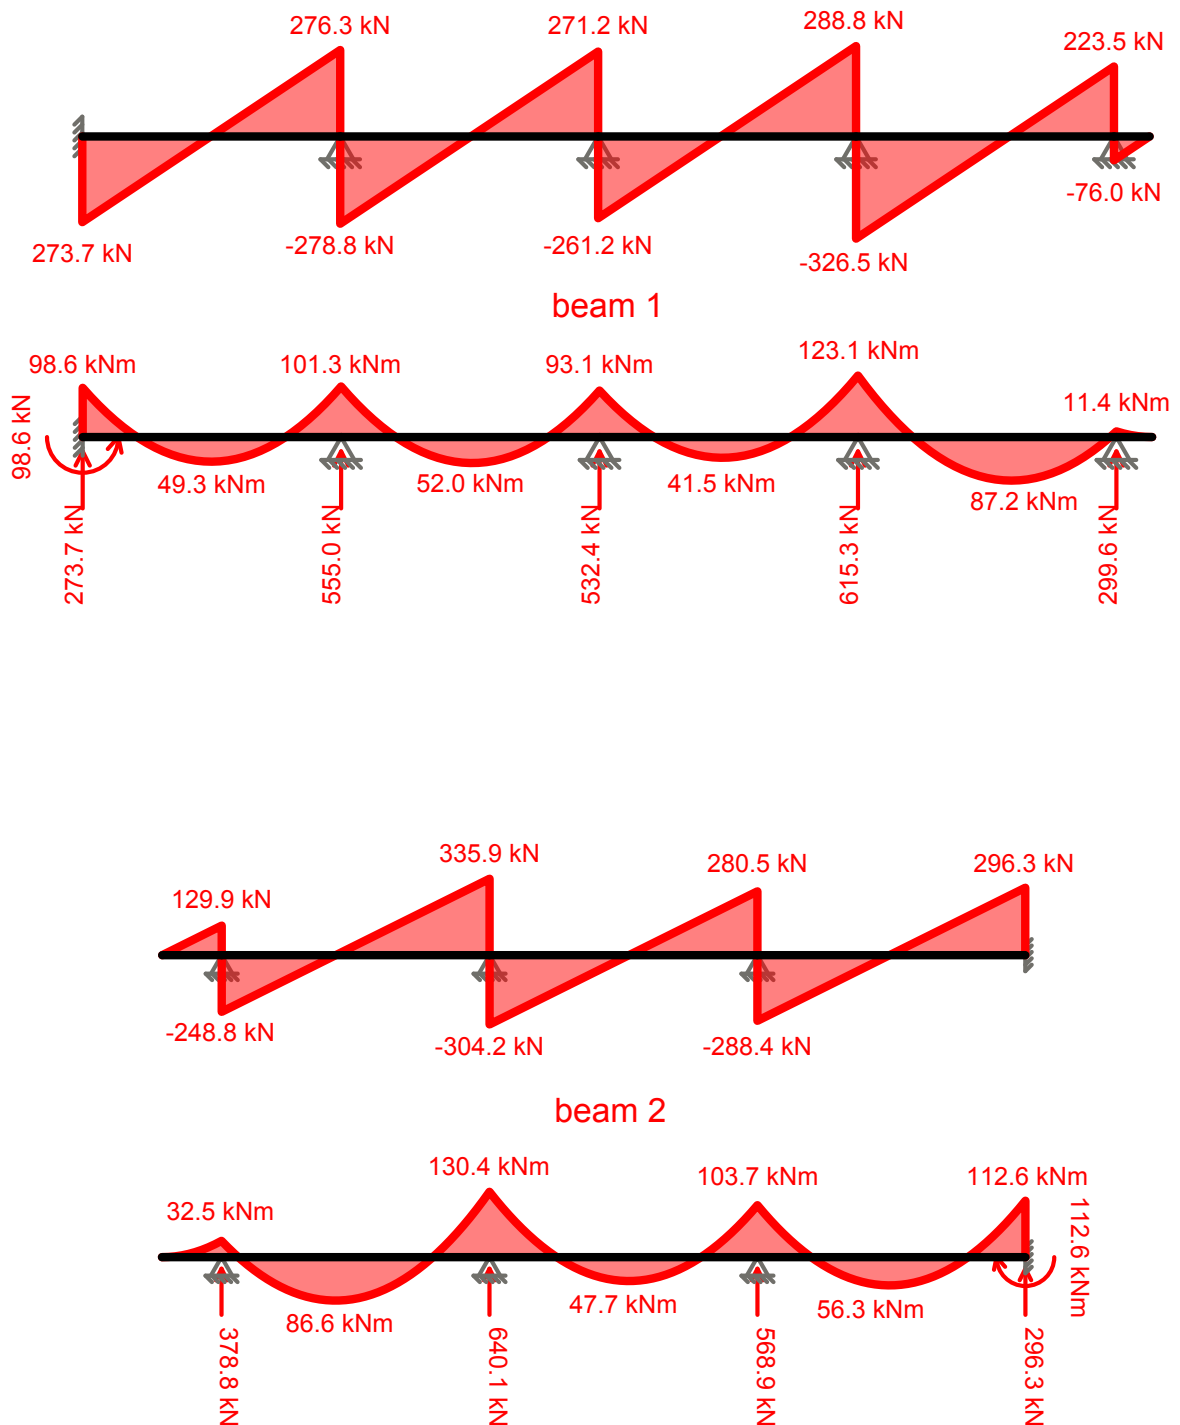
Figure B.1: Shear and bending moment diagrams on the beam 1 (on top) and beam 2 (on the bottom) for the update of the project (personal work)
